#### Inspection: 1309 Carolyn Ct Humble TX 77338

Report date: Apr 21, 2020

> > Type: Roof

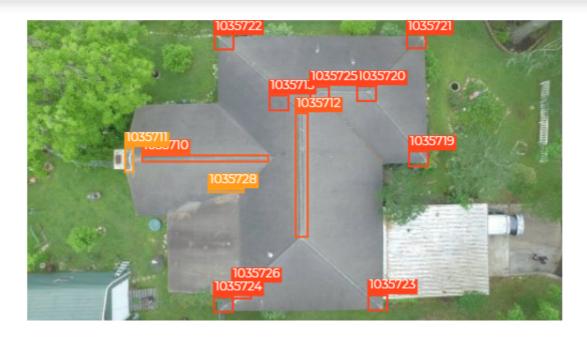
File name:	IMG_0358.JPG	Altitude:	22.4m
Date taken:	Apr 6, 2020 3:52:50 PM	Heading:	East (84.100006°)
Position:	29.9898694,-95.2551250	User tags:	No tags available

Id	Severity	lssues	Comments	Page
1035710	3	damaged vent	damage from animals chewing plastic vent sides	4
1035711	1	Worn section		4
1035712	3	damaged vent	damage from animals chewing through plastic vent sides	5
1035713	4	Worn section	shingles broken and worn from weather	5
1035719	4	Worn section		5
1035720	4	Worn section		5
1035721	4	Worn section		5
1035722	4	Worn section		6
1035723	4	Worn section		6
1035724	4	Worn section		6
1035725	4	Worn section		6
1035726	4	Worn section		6
1035728	1	Worn section	damage from roofing crew	7
